Manhole Inspection Summary

Manhole # S11MM_052MH

Insp Date: **8/29/07 5:19 PM**

Location Address: **3200 WINDSOR AVE**

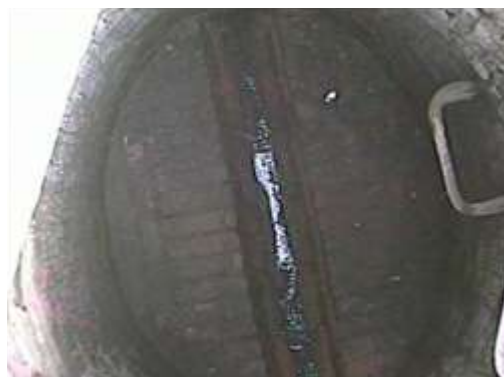
Defect 1

Count: **2** Missing: **0** ☒ **Corroded**

CORRODED STEPS

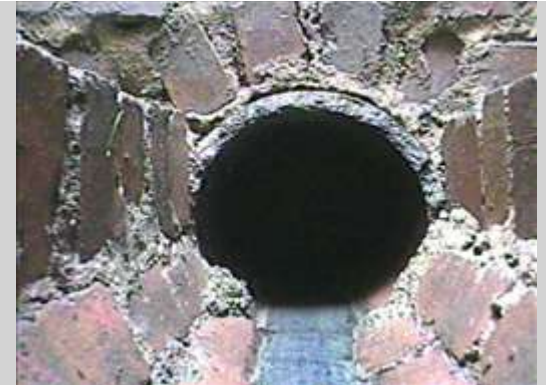
12 O'Clock Outflow

8 in. Circular Gravity Sewer
Pipe Out @ 12 O'Clock

Pipe Height: (in.) Direct
Pipe Material: **Clay** ☐ Pipe Lined
Invert Depth: **6.90** (ft.) Flow Characteristics: **Slow**
Deposits: ☒ None ☐ Mud ☐ Sludge ☐ Debris ☐ Grease
Silt Depth: (in.) Deposits Extent:
Infiltration: **None** Pipe Seal Cond: **Broken**

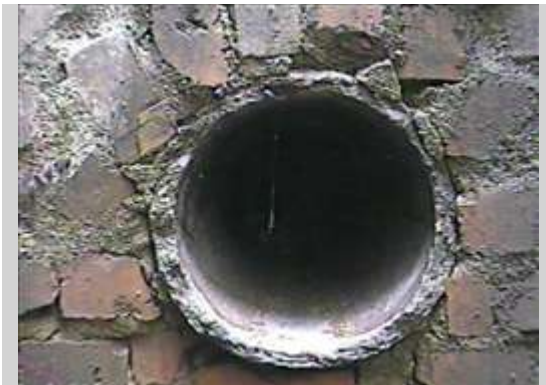
6 O'Clock Inflow

8 in. Circular Gravity Sewer
Pipe In @ 6 O'Clock

Pipe Height: (in.) Direct
Pipe Material: **Clay** ☐ Pipe Lined
Invert Depth: **5.81** (ft.) Flow Characteristics: **Slow**
Deposits: ☒ None ☐ Mud ☐ Sludge ☐ Debris ☐ Grease
Silt Depth: (in.) Deposits Extent:
Infiltration: **None** Pipe Seal Cond: **Sound**

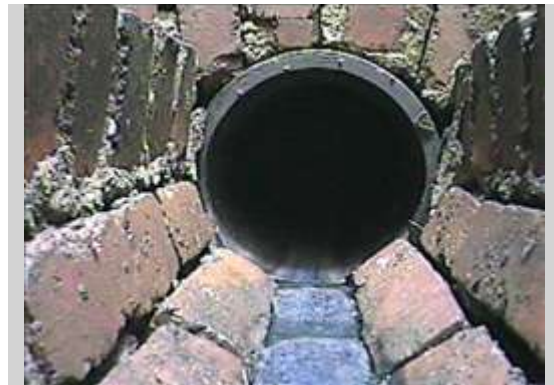
Drop In @ 6 O'Clock

Drop: **Outside Direct**
Angled: Reading: (ft.)
Inv Depth: **6.50** (ft.)

Drop Condition: **Open**
